# TEESCHOOLS

## Transferring Energy Efficiency in Mediterranean Schools

**DELIVERABLE NUMBER:** 5.3.3

**TITLE OF DELIVERABLE:** WP5 Renovation Plan for tested building  
**WP n. 5: CAPITALISING**

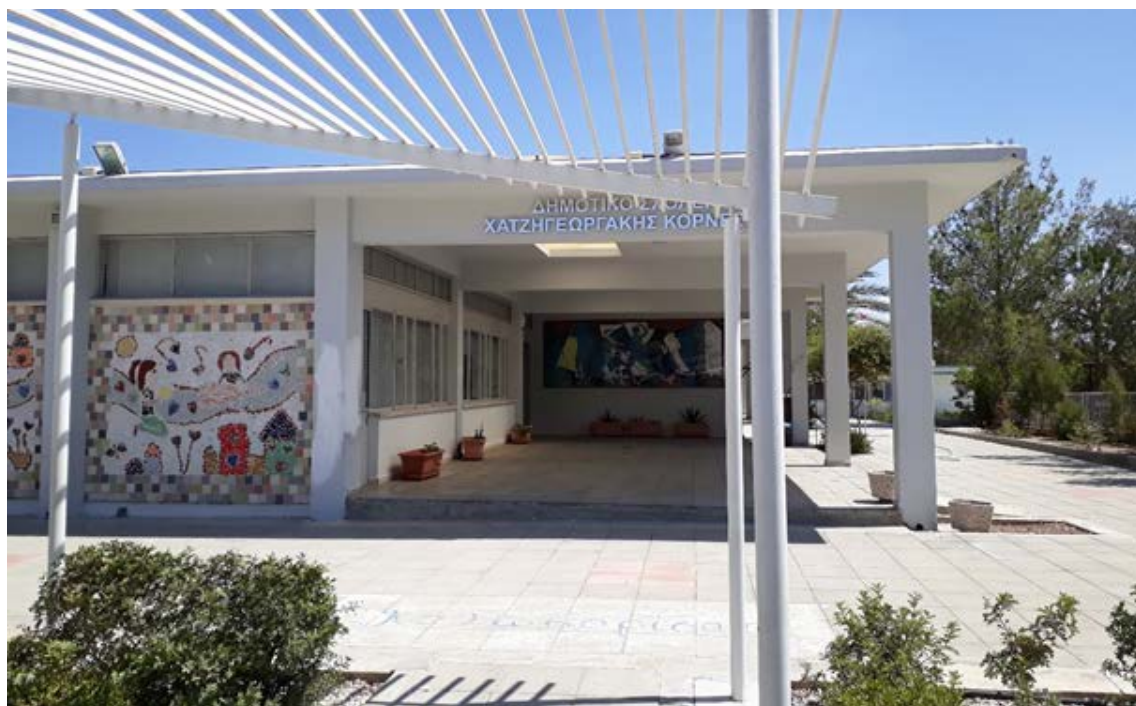
**FIGURE 6:** SCHOOL'S ENTRANCE - BLOCK A

The school consists of 2 distinctive blocks and a small, prefabricated, addition. The main block [Figure 6] was constructed in 1968. It expands on the ground level hosts 4 classrooms, the principles and administration offices, the teachers' room, one room for special teaching, the canteen, the cleaning staff room, toilets, storage rooms, the boiler room and the multipurpose hall in the centre. The second block [Figure 7] has an 'L' shape, it was constructed at a later stage in order to house additional classrooms and labs for the increasing number of students. It was erected in 2 stages; the first part of this block was given for use in 2004 whereas the 2nd one was finished in 2014. Block B hosts 3 labs (currently used as regular classrooms), 5 classrooms, 2 classrooms for special education, the school's infirmary, lockers rooms, toilets and a storage room. It comprises a ground floor and first floor. The last block, which is prefabricated, hosts just 2 classrooms for periodical use, mainly as laboratories.

The school's TFA is around 1,520 m<sup>2</sup>, with a volume of 4,969 m<sup>3</sup> (HFA: 1,286 m<sup>2</sup>). In specific, Block A has a TFA of 749 m<sup>2</sup> whereas Block B has a total TFA of 679 m<sup>2</sup>, of which 339 m<sup>2</sup> are on the ground floor and the rest on the first floor. The prefabricated structure has an area of 97 m<sup>2</sup>.

The total external surface consists of 1582.57 m<sup>2</sup> of masonry and bearing construction and 447.05 m<sup>2</sup> of openings (glazing). The average TFA of classrooms is close to 50 – 55 m<sup>2</sup> which is slightly lower compared to the design standards of the MoECY's Technical Services, which define the suitable classroom for 25 people to be 65 m<sup>2</sup>.

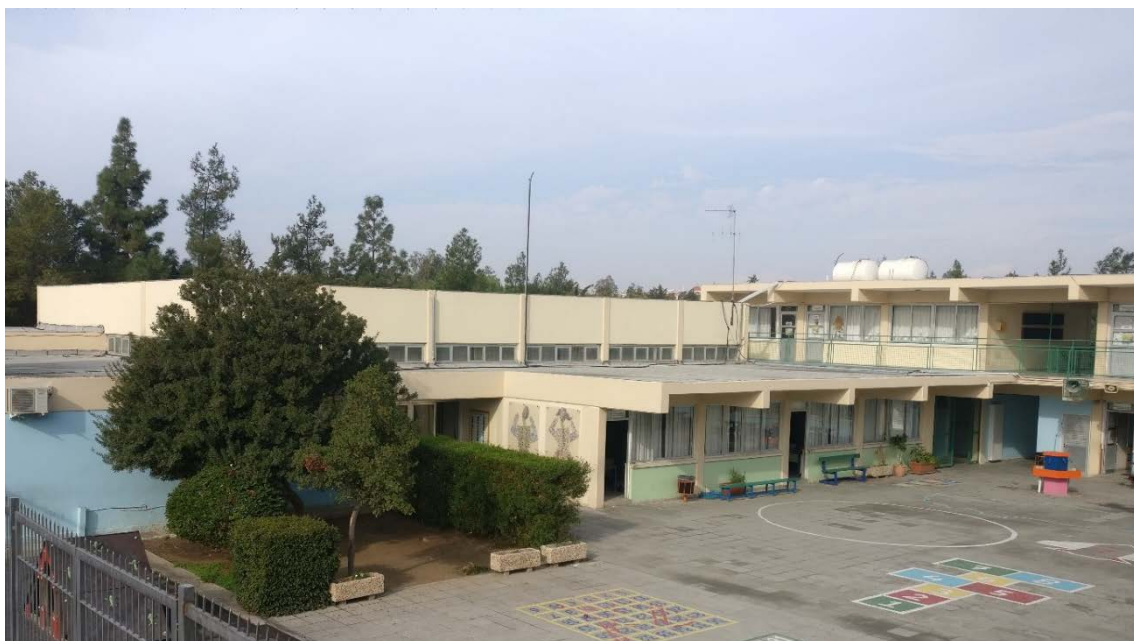
**FIGURE 9: BLOCK A [LEFT] – OLDER BUILDINGS (1986)**

The school consists of 2 distinctive blocks and a small, prefabricated, addition. The main block [Figure 9] expands on a ground level and it hosts 3 classrooms, 2 labs, the principles and administration offices, the teachers' room, the canteen, the cleaning staff room, the school's infirmary, toilets, storage rooms, lockers room, the boiler room and the multipurpose hall in the centre. The second block, has an 'L' shape and it was constructed in 3 stages; the first part of this block was constructed at the same time with the main block (at 1986), whereas the second part (3 classrooms) was given for use at 2008 [Figure 10]. The third part, which was an extra classroom and storage space, was constructed at 2013. The second block hosts in total, 14 classrooms, 1 lab, 2 classrooms for special education, toilets and a storage room. It comprises a ground floor and first floor. The last block is prefabricated and hosts just 1 classroom for periodical use, mainly as an art laboratory. The prefabricated part originally was consisted of 2 classrooms, but after the additions on Block B, it was removed.

The school's TFA is around 2,023 m<sup>2</sup>, with a volume of 6,771 m<sup>3</sup> (HFA: 1,830 m<sup>3</sup>). In specific Block A has a TFA of 1,151 m<sup>2</sup>, Block B has a total TFA of 825 m<sup>2</sup>, of which 418 m<sup>2</sup> are on the ground floor and the rest on the first floor. The Prefabricated classroom has an area of 47 m<sup>2</sup>, and a respective height of 2.65 m.

The total external surface consists of 1,935.20 m<sup>2</sup> of masonry and bearing construction and 527.95 m<sup>2</sup> of openings (glazing). The average TFA of classrooms is 55 m<sup>2</sup> which is lower compared to the design standards of the Technical Services.

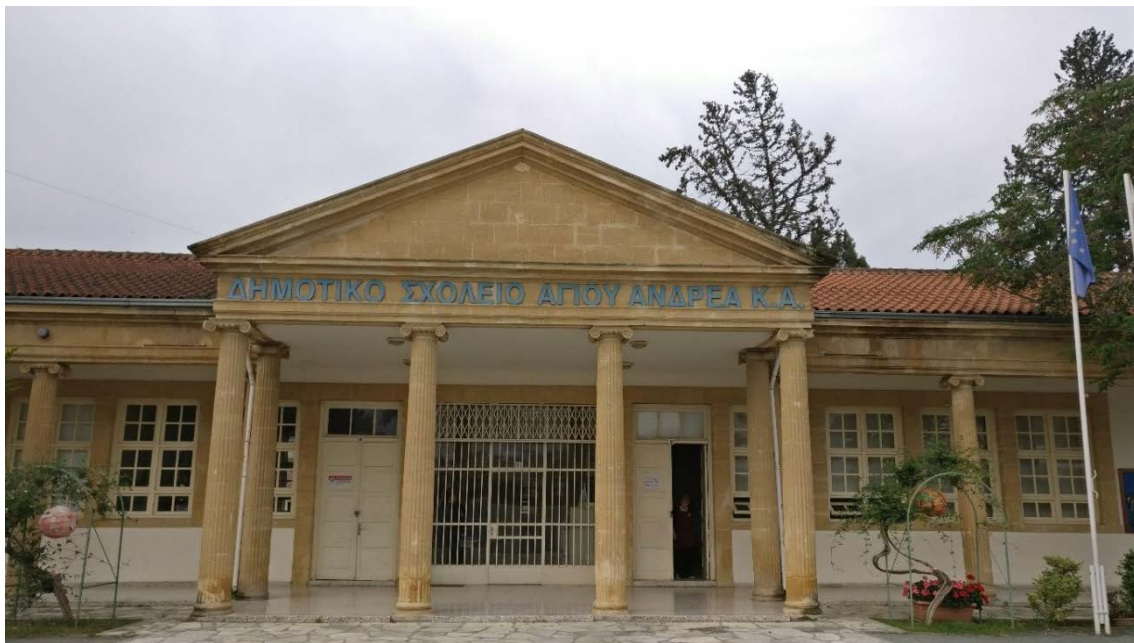
**FIGURE 12:** BLOCK A, LISTED BUILDING— ENTRANCE (NORTHEAST FAÇADE)

The CA's building ('Block A'), comprises a floor and a pitched tiled roof [Figure 12]. It hosts 6 classrooms, the principles and administration offices (reception area), the teachers' room, multipurpose room, the cleaning staff room and two toilets for the staff. In 2 small adjacent buildings are hosted a special education classroom and the boiler room with 2 storage rooms and 2 toilet rooms. There are also separate buildings that are used as a storage spaces (2 of those are prefabricated). Lastly, there are 2 buildings that are used by the scouts<sup>4</sup>. The second building ('Block B'), was constructed in the 70s and operated in 1972. In its core is the multipurpose room, which is surrounded by administration spaces, classrooms (x3), labs, the school's infirmary, toilets, locker rooms and storage rooms. It only consists of a ground floor [Figure 13]. The third building ('Block C'), also operated for the first time in 1972. It also serves the 2<sup>nd</sup> Cycle and has in total 5 classrooms, 3 labs, 1 classroom for special education, 1 room used as library, 1 canteen, toilets, storage rooms and the boiler room. It comprises a ground floor and first floor [Figure 14].

Approximately half of the total external surface of the Block A is covered by openings, whereas for the South and North Façade of Block B and C the proportion is around 30%. East and west facades of Block B and C have the lowest proportion of openings, around 15% -20%. The average TFA of classrooms is  $67 \text{ m}^2$ , which is consisted with the design standards of the Technical services.

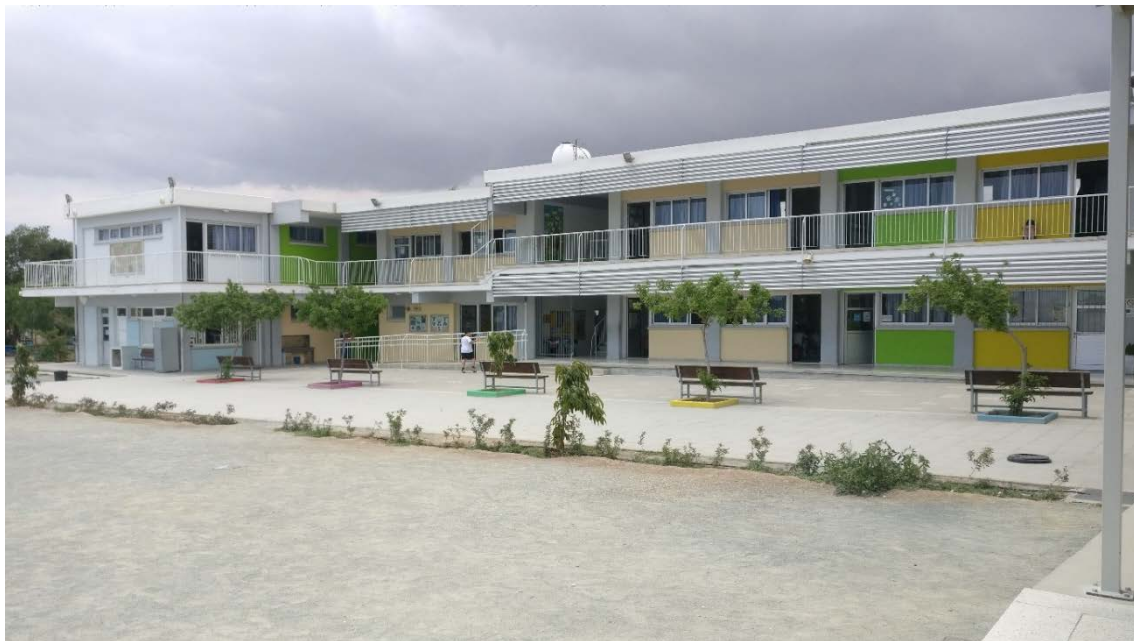
**FIGURE 16:** BUILDING UNDER STUDY - PART OF EAST FAÇADE

The school/building acquired its first form on 1989, and it was consisted of a ground floor and a first floor. The school was undergone an anti-seismic upgrade on 2008 and some alterations took place at the same time. In specific, 4 new spaces were added on the first floor and a new staircase was added at the North-eastern part of the building. Currently, the ground floor hosts 2 classrooms, 1 special education classroom, 2 labs (Technology and Cooking Lab), the administrative offices, the teachers' room, the cleaning staffs' room, the canteen, toilets, storage spaces, and the boiler room<sup>5</sup> whereas the 1<sup>st</sup> floor hosts 7 classrooms, 1 classroom for special education and a storage space [Figures 16 & 17]. It's noted here that the CB uses also the ground floor of a newer building<sup>5</sup> which belongs to the CB (indicated in Figure 18), in order to host 2 more classrooms and 1 special education classroom. On the same floor it's also the music lab, the school's infirmary, the locker rooms, storage spaces and toilets which are shared among the 2 cycles.

Approximately 40% of the total external surface of the East Façade (main facade) is covered by openings, whereas for West façade (school's entrance), the proportion is around 20% which is the lowest. Openings on the North facades are about 30 % in total and on South facades 40%. The average TFA of classrooms is 55 m<sup>2</sup>, which is lower compared to the design standards of the Technical Services.

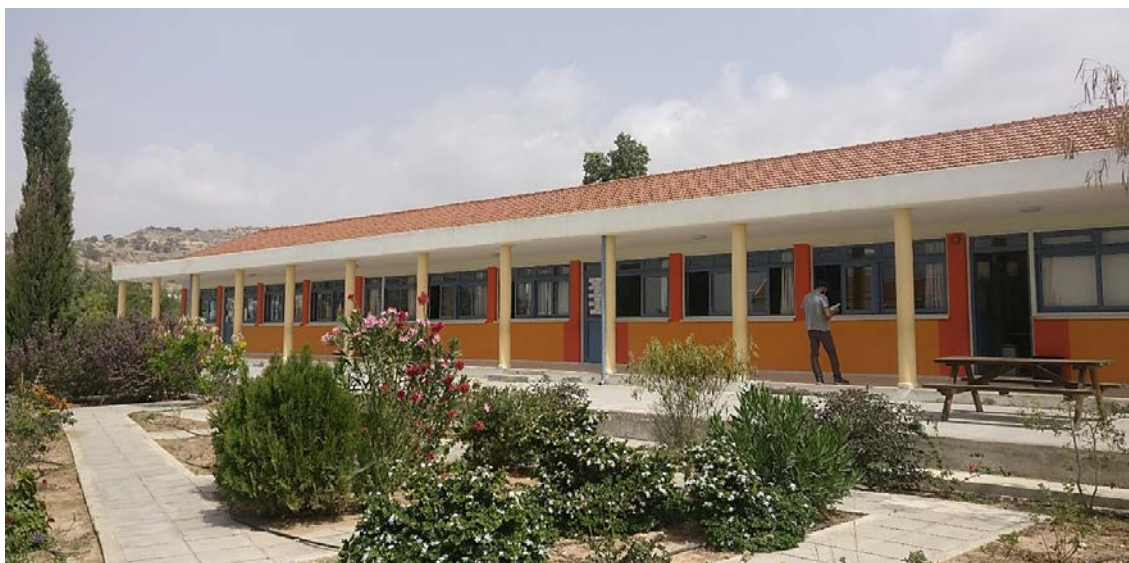
**FIGURE 20:** BLOCK A - CONSTRUCTED IN 1964 (SOUTH FACADE)

The 1<sup>st</sup> Block ('Block A'), was constructed 1964 and is the oldest one [Figure 20]. It has a long rectangular plan view and is the only one that has pitched, tiled roof. It consists of a ground floor and it hosts 3 classrooms, 1 lab (cooking lab), 1 classroom for special education, storage spaces, toilets and the school's infirmary.

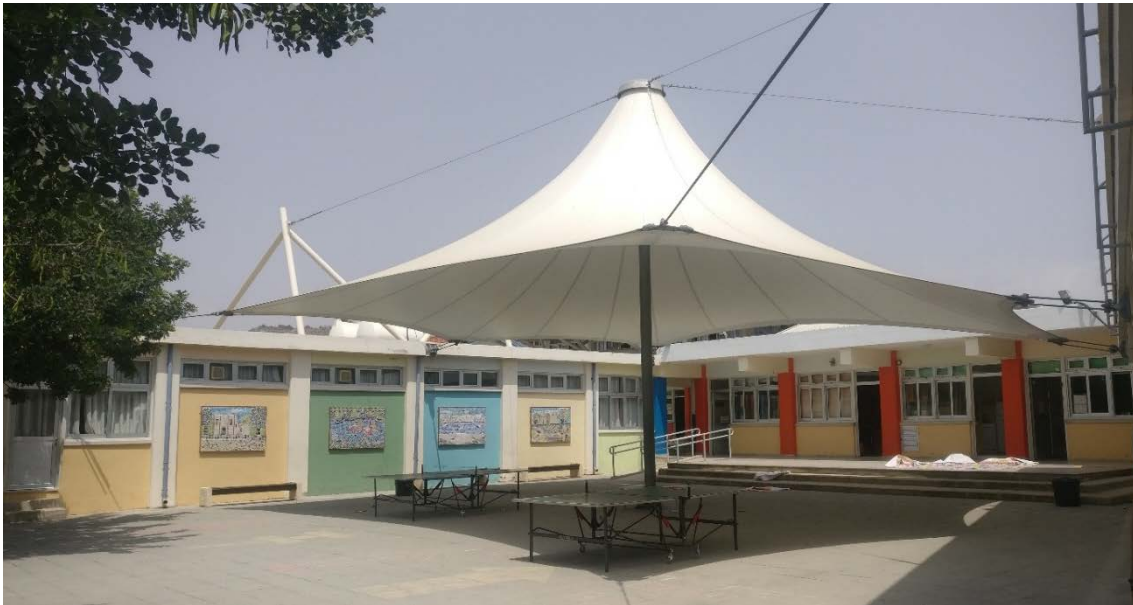
**FIGURE 21:** BLOCK B [LEFT] AND BLOCK C [RIGHT] - CONSTRUCTED IN 1979 AND 1985 (EAST AND SOUTH FAÇADE RESPECTIVELY)

The 2<sup>nd</sup> Block ('Block B'), was constructed in 1979, followed by the 3<sup>rd</sup> Block (Block C), few years later (in 1985). Both are consisting of a ground floor and together they formed an 'L' shape east of Block A [Figure 21]. Block B hosts 1 classroom, 1 lab (Art Lab) and 1 classroom for special education and other activities. Block C hosts mainly the administrative spaces, as it is on central spot. In specific, the principal's office, the assistants' principals office and the secretariat's room are on Block C. The cleaning staff's room, the computer's Lab and the boiler room are also hosted at Block C. The 4<sup>th</sup> Block ('Block D'), was constructed in 2 different phases [Figure 22]. By 1992 the first part was delivered, it included 2 classrooms and toilet rooms on the ground floor. By 2001 the 2<sup>nd</sup> part was delivered. It included 3 classrooms on the 1<sup>st</sup> floor. The construction of the 5<sup>th</sup> Block ('Block E'), was also delivered in 2 phases [Figure 23]. On 2005 the 1<sup>st</sup> part (ground floor) was delivered, whereas the 1<sup>st</sup> floor was completed in 2009. On the ground floor there are 2 classrooms, 1 classroom for special education, the teachers' room, the school's canteen, storage spaces and toilets. On the 1<sup>st</sup> floor there 4 classrooms and one classroom for special education. The last and newest -completed- addition was the 6<sup>th</sup> block ('Block F'), at the north site of the plot [Figure 24]. It was completed in 2015 and it hosts just 4 classrooms, 2 on the ground floor and 2 on the 1<sup>st</sup> floor. The Multipurpose Hall, which was currently under construction, will be located West of Block F.

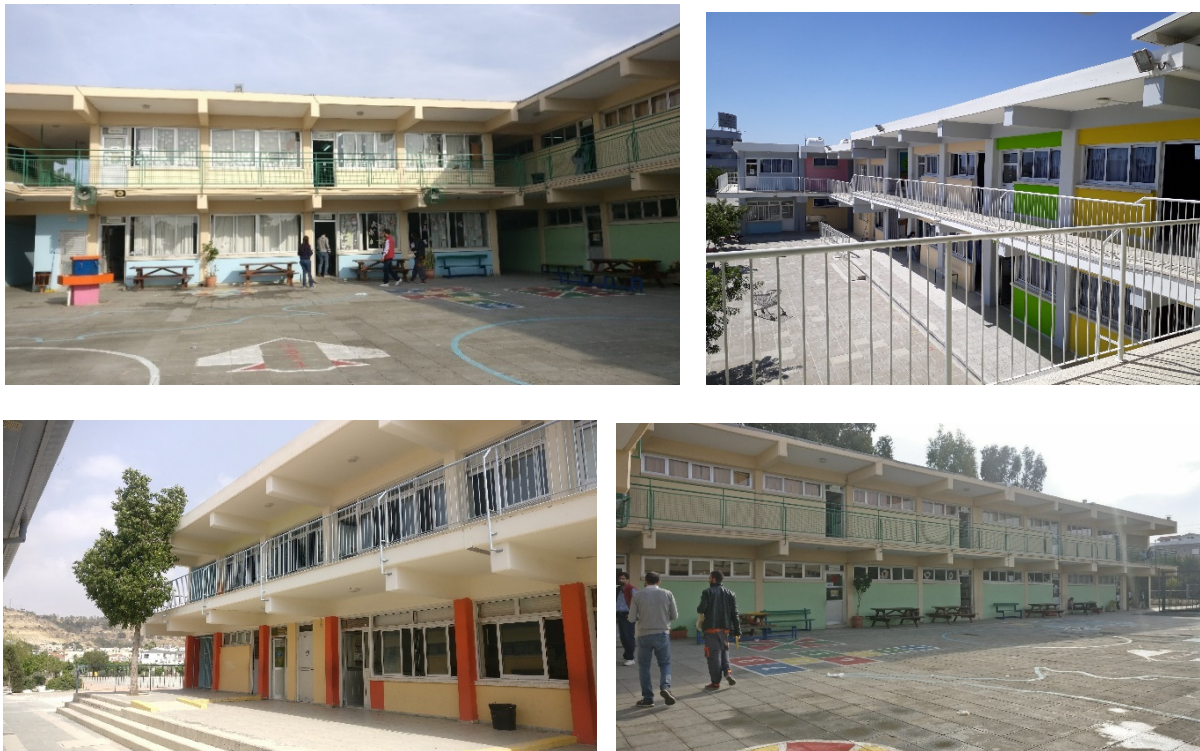
**FIGURE 25:** SIMILARITIES IN SCHOOL BUILDINGS DESIGNED BY THE TECHNICAL SERVICES [PILOT BUILDINGS – AYIOS GEORGIOS, LIVADIA, VOROKLINI]

The first educational buildings in Cyprus were constructed in accordance to the style of the era (Ottoman and British rule) and to serve specific needs of the community. The majority of the schools constructed during the British era follow the neoclassic style. During the 1950 – 1974 most of the schools were constructed by representatives of the modern architecture movement in Cyprus, and even if they don't follow specific guidelines they are characterized by common characteristics. Since the establishment of the Technical Services of the Ministry of Education, Culture, Sports and Youth [mostly after 1974], schools are constructed based on specific Guidelines. They have a consistency in construction materials and typical floor plans and facades, usually with an 'L' or 'n' shape [Figure 25], expanded on the West-East Axis. Exceptions are the schools constructed as a result of architectural competitions. This kind of schools usually fall far from the typical forms [Figure 26].

Cyprus' pilot schools fall within the majority of the public school building stock as they were constructed from the Technical Services. Exception is the listed building of Ayios Andreas which dates back to the British rule and the Block A of Voroklini primary school. These examples were selected to identify opportunities for energy savings and improved educational environment in historic buildings.

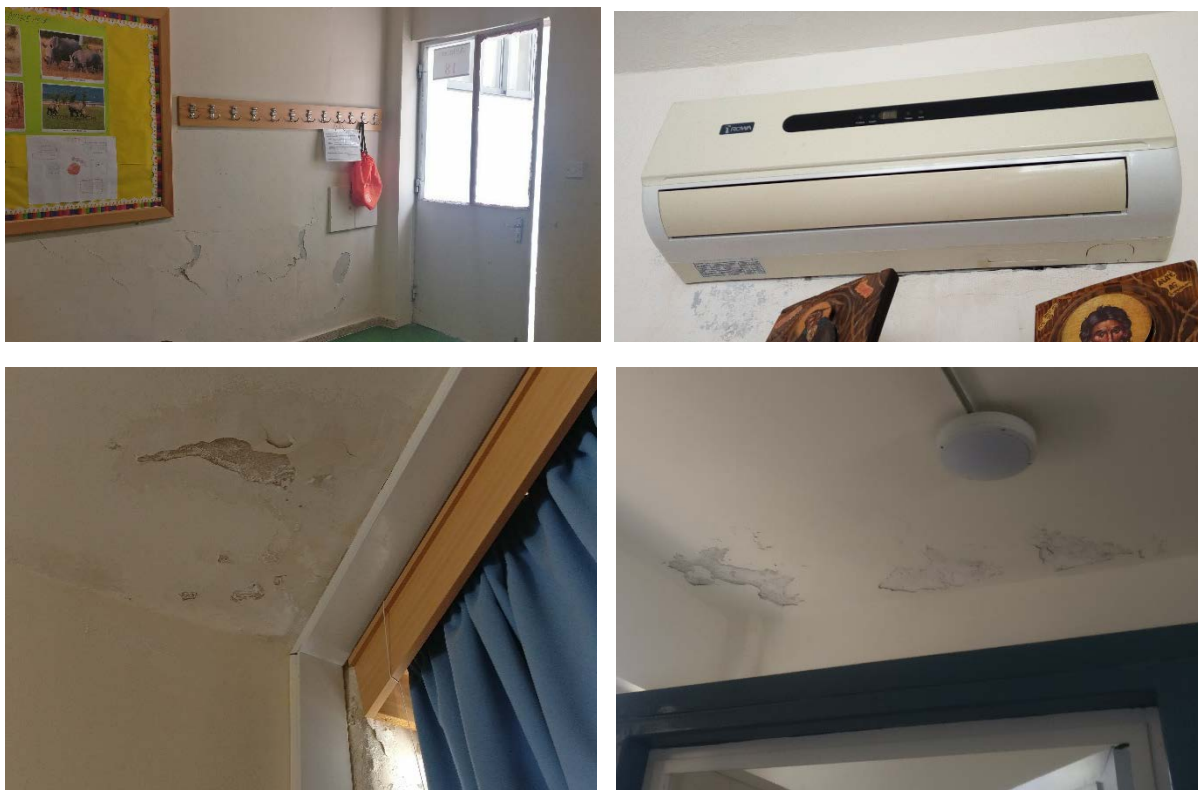
In some of the school buildings [Lakatamia, Ayios Andreas, Voroklini], the auditing team also noticed that condensation problems occurred on some interior walls and roofs of various spaces of the schools, such as classrooms and storage rooms [Figure 28]. Those can compromise building occupants' health and comfort, damage interior finishes, and raise maintenance costs. The problems of condensation in most of the spaces are due to the existence of thermal bridges on the junctions between the wall and roof. Those can be addressed with the placement of thermal insulation across the hole building's envelope. This option, however, is only foreseen under the holistic upgrade scenario that leads building to a NZEB.

The second category of condensation and humidity problems derives from failures of the waterproofing sheet or technical installations. The first can be resolved with the inspection of the waterproofing in order to locate the failures and then, removal and re-fitting of the waterproofing sheet before the plastering and painting of the roof. In the case of the technical installations, caution should be taken in order to resolve the problem before deteriorates.

The last category of condensation problems, which mainly affect the structural elements (like walls), were found mainly on closed spaces, like the storage and locker rooms. Those concern cases of poor ventilation conditions, therefore, it is suggested by the energy auditors' team to regularly ventilate the spaces when and where possible.

**FIGURE 28:** CONDENSATION AND HUMIDITY PROBLEMS PRESENTED IN VARIOUS SPACES OF THE PILOT SCHOOLS

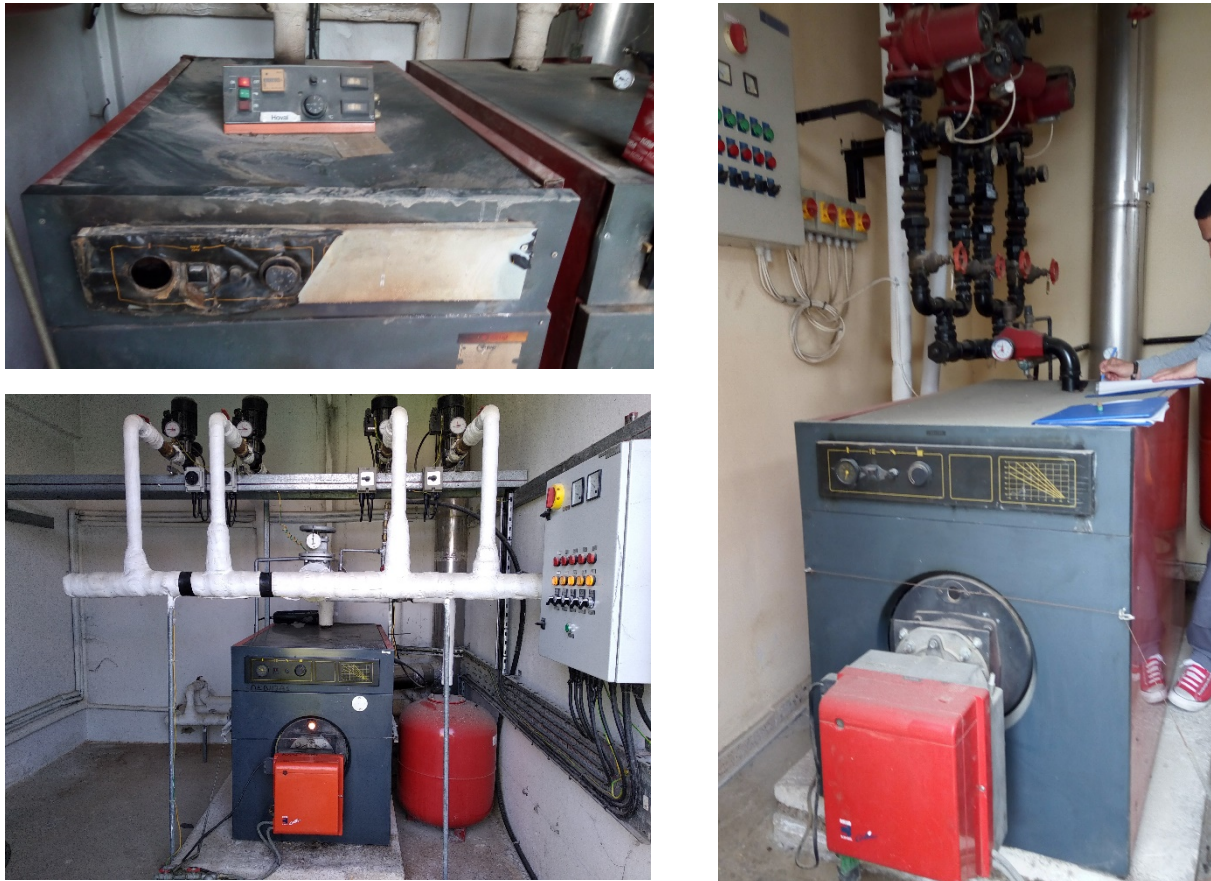
All pilot school buildings use oil boilers for covering their heating demand. The systems are used to heat the premises (classrooms, offices) of the building starting from late November or early December, until late March. The systems consist of a cast iron boiler (sometimes more than 1) in association with an oil-fired burner. Most of the boilers are more than 10 years old with efficiencies varying from 76% to 93%. The systems are usually maintained 1-2 times per academic period, nonetheless maintenance and service reports are not always available. The piping system feeding the terminal systems (radiators) with hot water is most of the times no insulated except within the boilers' rooms.

**FIGURE 30:** INDICATIVE OIL BOILERS LOCATED AT PILOT SCHOOLS. UP LEFT: DESTROYED BOILER AT AYIOS GEORGIOS SCHOOL. DOWN LEFT: LIVADIA [CB] BOILER. RIGHT AYIOS ANDREAS [CA] BOILER.

School	Measured efficiency of boiler(s)	Efficiency after adjustments	Notes & Recommendations
1	94.5%	92.5% due to the imperfect thermal insulation of the boiler	To clean the boiler's surfaces and adjust the operation of the burner as during the visual inspection of the combustion chamber revealed soot deposits in the flame chamber and, a high combustion air ratio was found [2.04 instead of 1.22]. Inadequate low flue gas temperature [98.5°C instead of 160°C-180°C] was also found indicating the inefficient operation of the burner. Based on the above the working conditions of the boiler and burner was found <b>inefficient calling for immediately corrective actions</b> .
2	80.74% [-]	78.7% due to the imperfect thermal insulation of the boiler	It was observed that one of the two boilers was highly destroyed from the emitted heating and was out of the operation for the last years. The auditing team <b>consider for inspection only the boiler that was in operation</b> . There was inadequate inspection and maintenance of the boiler, and the burner's operating conditions need adjustments. <b>Extensive cleaning of the heat transfer surfaces</b> is also needed, as the combustion chamber has soot deposits. A high combustion air ratio was found [3.10 instead of 1.22]. Moreover, high oxygen content on the flue gas was measured [14,2% instead of 3%-5%]. Based on the above, the working conditions of the boiler and burner was found <b>inefficient calling for immediately corrective actions</b> .

3*	83.2% [A] 79.1% [B] 78.6% [C]	80.26% Weighted efficiency as there is common energy bill	<p><b>Boiler A [CA]:</b> It is needed to <b>clean and adjust the combustion of the device</b> because there are soot deposits at the base of the chimney. The chimney of Boiler-A has a very small length, which results to rainwater penetration and the exhaust gases do not flow upwards, causing oxidation at various points, even inside the combustion chamber. It is recommended to <b>replace the chimney</b>. In addition, most of the pipes in the boiler room (A) are very rusty and partly insulated, so it is recommended to replace them with new ones that will be insulated externally.</p> <p><b>Boiler B [CB]:</b> There is need <b>to clean and regulate combustion of the device</b>. Additionally, it is observed an increased exhaust temperature of about 15°C (265°C) with respect to the maximum allowable temperature of 250°C.</p> <p><b>Boiler C [CB]:</b> There is need to clean and regulate combustion of the device. In addition, based on optical inspection, it is recommended to <b>insulate the pipes which are directed to and from the pumps of Boiler-B and C</b> which do not have insulation.</p>

4*	93.3%	-	In this case there are questions on both the validity of the readings of the gas analyser and the settings of the boiler-chimney system as according to the manufacturer the maximum rated efficiency, at full load does not exceed 90.7%. The boiler was left to reach steady state for more than 35 minutes before the first reading was taken and a further 10 minutes when a second one was taken, which verified steady state conditions. Furthermore, the CO/CO <sub>2</sub> ratio was found null as was the CO levels. Even though the readings may be erroneous, <b>corrective actions and professional maintenance</b> as per manufacturer's recommendations should be carried out. Based on findings of the optical inspection the auditors suggest <b>replacing the old insulation with new and thicker</b> as most of the pipes in the boiler room were partly insulated. It is also recommended to <b>remove the objects that cover the heating panels</b> and prevented the air circulation which reduces their performance.

5*	77.4%	-	There is a need to <b>clean and adjust the combustion of the device</b> (burner settings). <b>Further adjustment</b> as to the temperature settings and the chimney duct sizing and/or damping <b>should be considered since the combustion air ratio was measured to be equal to 2.73 [instead of 1.22]</b> . The flue gas water temperature exceeds the rated (labelled) temperature, of 200 °C by 65 °C, which ultimately deems the <b>performance of the boiler system poor</b> . Furthermore, the CO/CO <sub>2</sub> ratio was found null as was the CO levels. Even though the readings may be erroneous, <b>corrective actions and professional maintenance</b> as per the manufacturer's recommendations should be carried out. In addition, based on findings of the optical inspection the auditors observed that most of the pipes in the boiler room were partly insulated, so it is recommended to <b>replace the old insulation with new and thicker</b> .

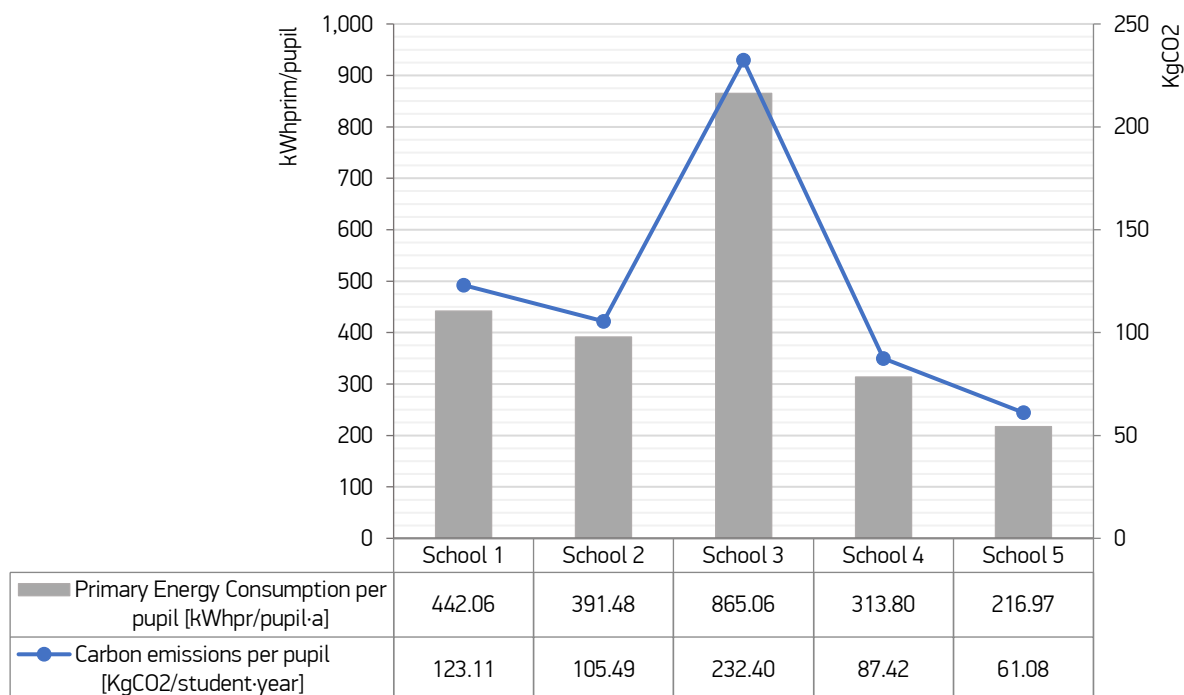
**GRAPH 6:** AVERAGE ANNUAL PRIMARY ENERGY CONSUMPTION AND CORRESPONDING CO<sub>2</sub> EMISSIONS PER PUPIL, FOR EACH OF THE PILOT SCHOOLS

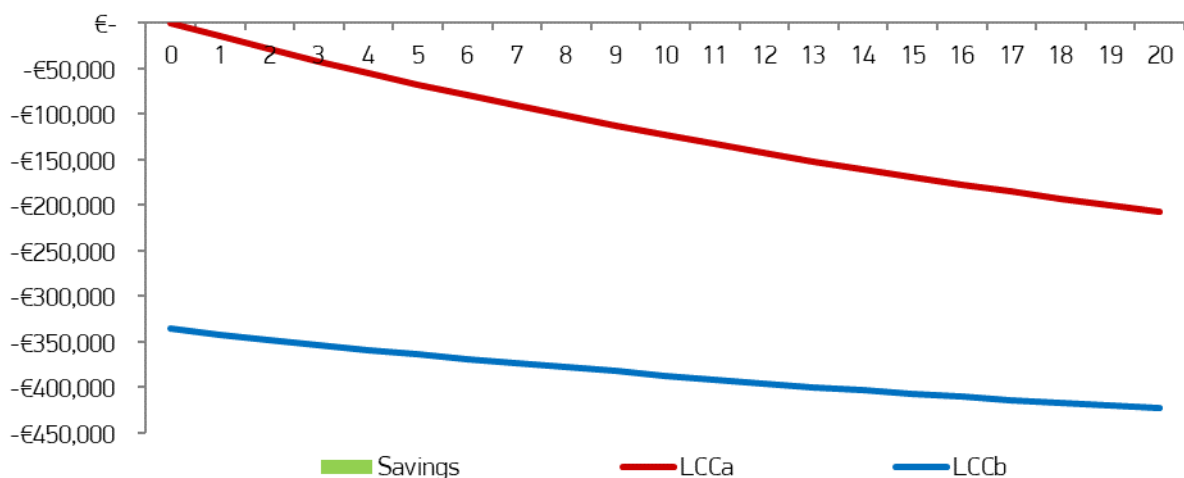
**GRAPH 9:** CUMULATIVE CASH FLOWS FOR THE IMPLEMENTATION OF THE NZEB FOR SCHOOL #3 (COMPARISON OF LCC<sub>A</sub> AND LCC<sub>B</sub>)

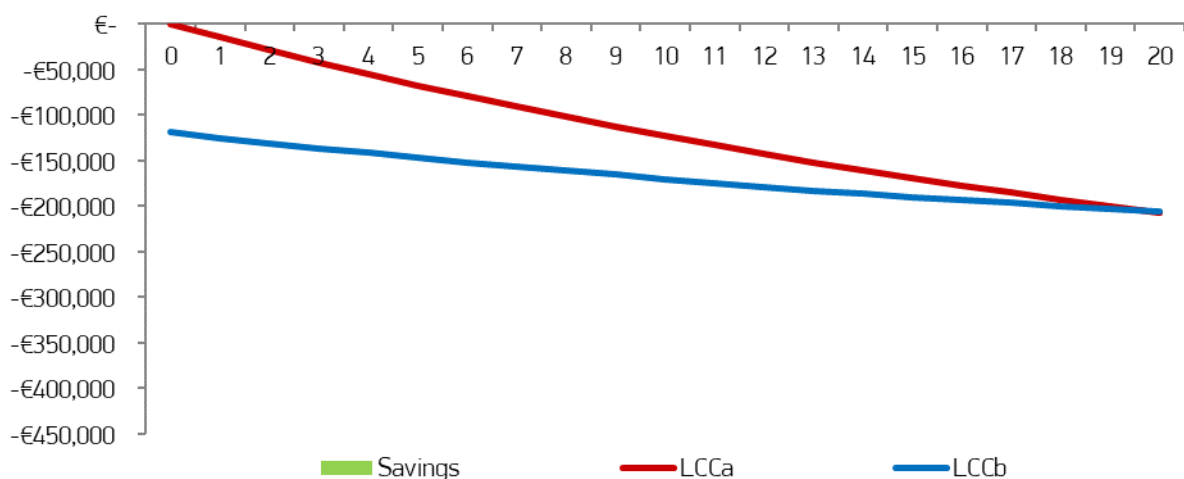
**GRAPH 10:** CUMULATIVE CASH FLOWS FOR THE IMPLEMENTATION OF THE NZEB FOR SCHOOL #3 -INCLUDING THE STATE SUBSIDY OF 64.5% (COMPARISON OF LCC<sub>A</sub> AND LCC<sub>B</sub>)

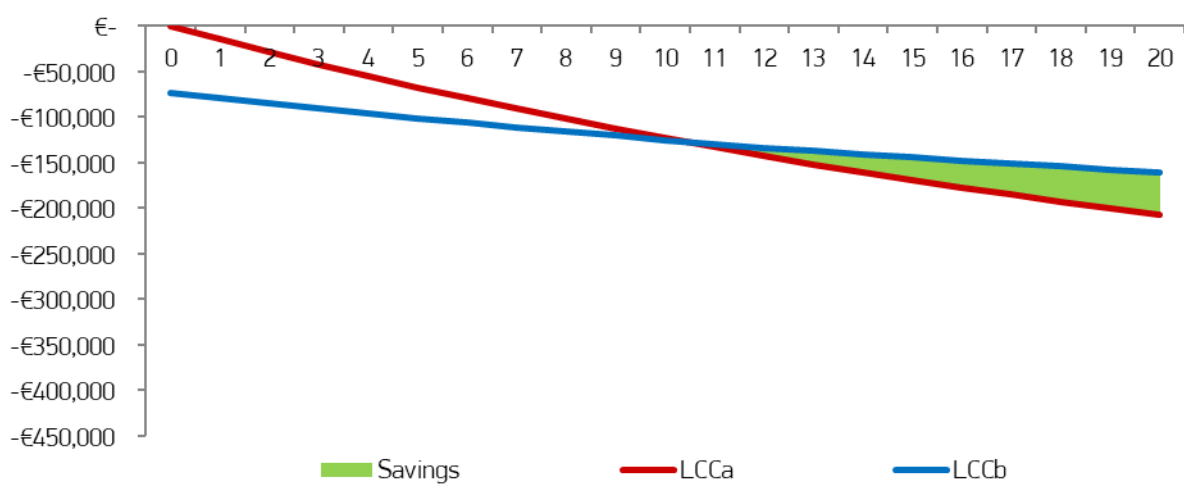
**GRAPH 11:** CUMULATIVE CASH FLOWS FOR THE IMPLEMENTATION OF THE NZEB FOR SCHOOL #3 -INCLUDING A STATE SUBSIDY OF 78% - AVERAGE SUBSIDY  
 NEEDED FOR THE 5 PILOT SCHOOLS (COMPARISON OF LCC<sub>A</sub> AND LCC<sub>B</sub>)
